Manhole Inspection Summary

Manhole # S13Q__017MH

Location Address: **2408 Wilkens Ave**

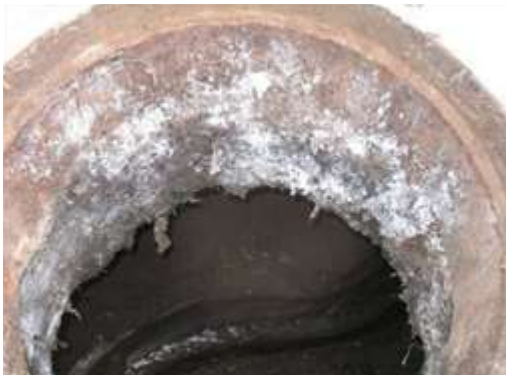
Miscellaneous

frame adjustment infiltration

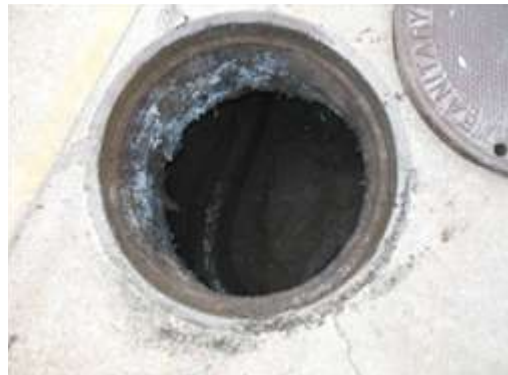
Misc

frame view

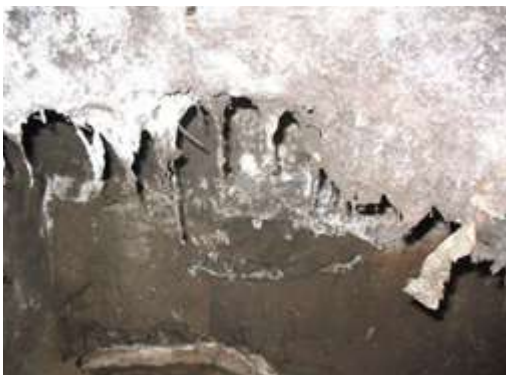
Defect 4

corbel infiltration

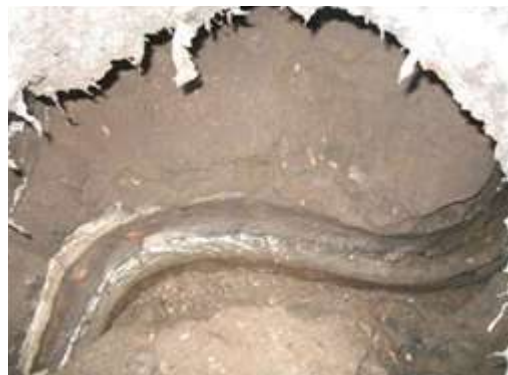
Defect 2

Channel condition debris

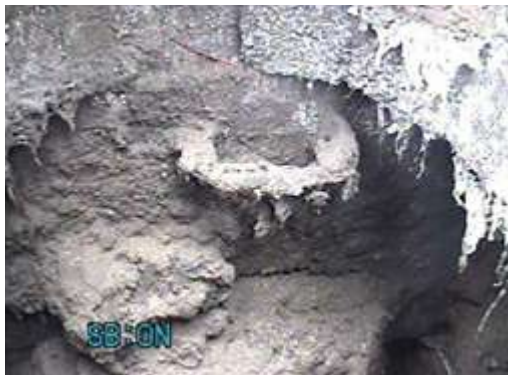
Defect 1

corbel infiltration, evidence of surcharging
4 feet

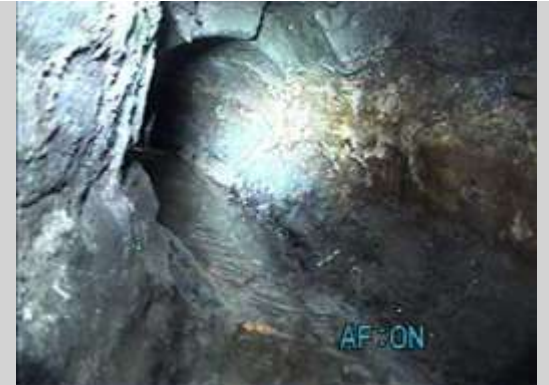
12 O'Clock Outflow

Deposits: ☐ None ☒ **Mud** ☐ Sludge ☐ Debris ☐ Grease

Silt Depth: 8 (in.) Deposits Extent: **Medium**

Infiltration: **Evidence** Pipe Seal Cond: **Unknown**

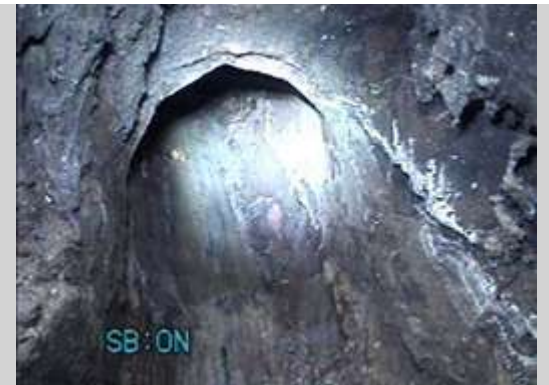
6 O'Clock Inflow

Deposits: ☐ None ☒ **Mud** ☐ Sludge ☐ Debris ☐ Grease

Silt Depth: 8 (in.) Deposits Extent: **Medium**

Infiltration: **Evidence** Pipe Seal Cond: **Unknown**
